EXTENDING THE SERVICE LIFE OF BUILDINGS AND INFRASTRUCTURE WITH FIBRE COMPOSITES

Matthew F Humphreys¹, Queensland University of Technology, Brisbane, Australia

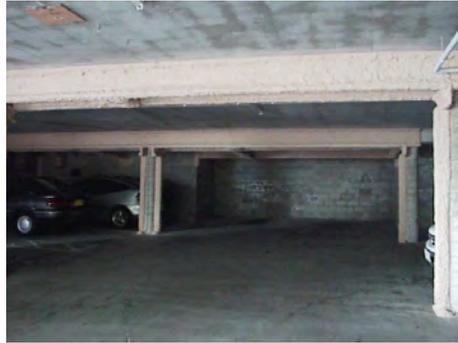
Figure 1 – Strengthening / stiffening suspended concrete slab with steel beams

Constructed facilities suffering from poor structural performance or those which have become functionally obsolete may need to be repaired, reconstructed, strengthened or reconfigured in order to continue performing as expected. Existing methods often involve the use of steel to strengthen or stiffen concrete and can be extremely expensive and cumbersome. Figure 1 shows an internal concrete span which has been stiffened and strengthened by the addition of a large steel member encased in fire protective vermiculite. The steel universal beam is supported at the ends on new steel columns and fixed to the slab soffit by closely spaced bolts. This method of fixing is expensive and labour intensive while the application of external fire protection involves another step in the installation process.

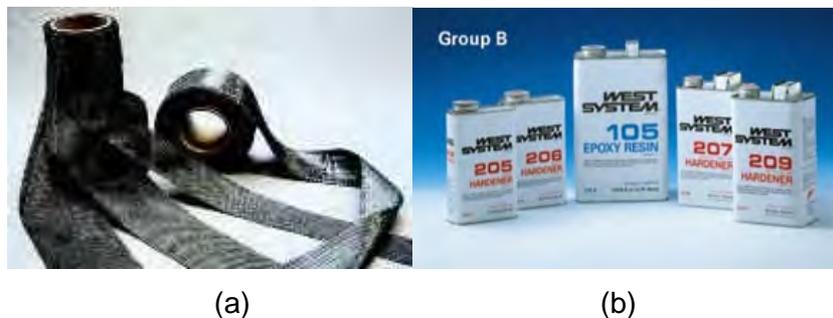
**Figure 2 – a) Carbon fibre b) Epoxy resin
(Source [16])**

The end of the "Cold War" in the late 1980's produced a glut of fibre composites resources looking for new applications. This has brought about development of reinforcing fibres such as carbon and aramid which offer improved strength and stiffness and better impact performance over glass. Figure 2a shows carbon in the form of a roll of dry woven fibres. Resins have also undergone considerable development, most significantly the introduction of different polyester, vinylester and epoxy formulations. These new resins offer improved performance over the original high temperature curing phenolic resin in areas such as mechanical properties, chemical resistance and bonding. Figure 2b shows a typical two-part epoxy laminating resin.

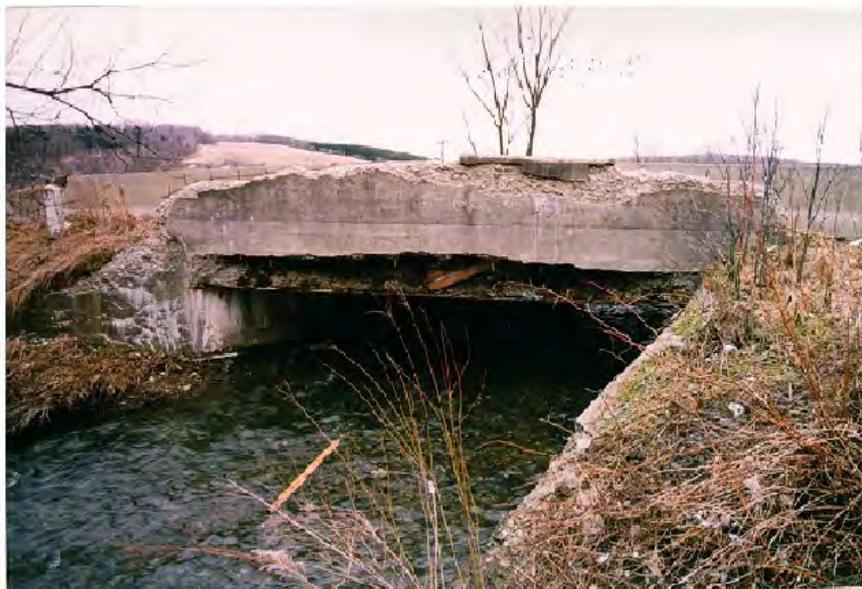
**Figure 3 – Existing deteriorated bridge
(Source [20])**

The reinforced concrete bridge, constructed in 1926, had undergone significant deterioration from de-icing salts and its capacity had been accordingly reduced to 10 tonne (refer Figure 3). A large proportion of heavy vehicle traffic was required to detour through local roads creating additional transport cost and upset to local residents. A capital construction project being designed would upgrade the crossing in January 2000. This was viewed by local residents as too long to wait and a temporary solution was investigated.

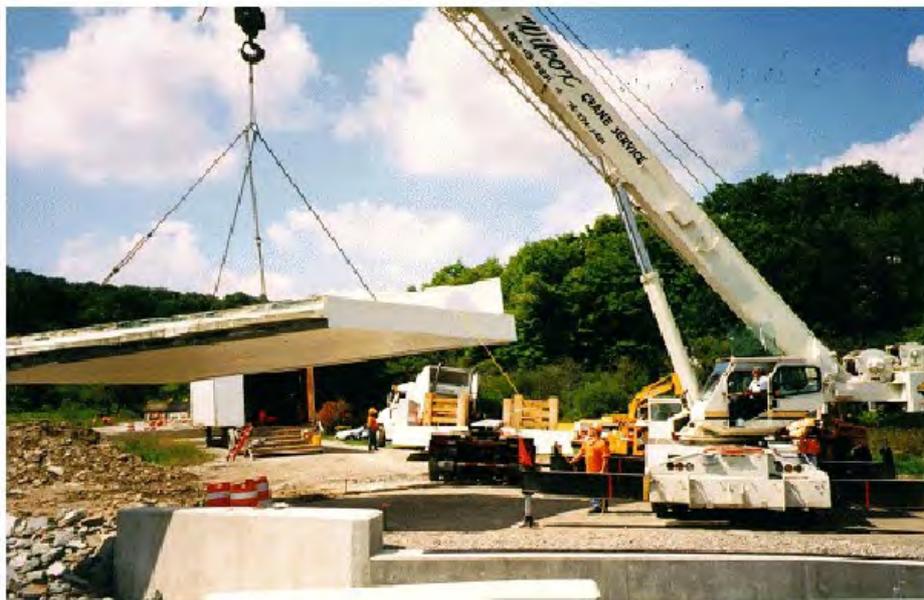
**Figure 4 – New modular FRP bridge deck
(Source [20])**

An on-site detour was constructed to allow passage of light traffic while the bridge was undergoing reconstruction. An FRP structure was chosen primarily due to its resistance to icing salts, light weight and ability to allow the bridge to be made in two lightweight modular components which could be transported to site inexpensively and assembled rapidly on site (refer Figure 4).

New bridge abutments were constructed while the deck was being designed and constructed in the factory. The new bridge was delivered to site and installed within six hours. Follow-up work, including railings and approaches were completed within six months. The estimated cost for the project was around US\$400,000 compared to an estimated US\$1.45M required for the permanent upgrade. However, the cost estimate for construction of the FRP bridge deck omitted a number of costs such as cost of in-house engineers and researchers, overhead charges and manufacturers profit.

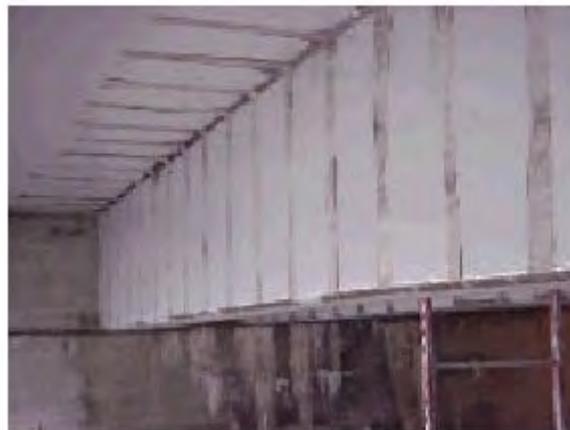
**Figure 5 – Externally bonded FRP plates
(Source [21])**

Externally bonded steel plates have been used in applications like this since the early sixties and are a proven method of improvement with little imposition to bridge traffic. However steel plates can be difficult to install and can suffer from corrosion if exposed to the environment. FRP laminates were chosen over traditional steel plates due to their versatility, ease of installation and excellent durability. Figure 5 shows the FRP plates externally bonded to the bridge T-beam.

Subsequent analysis at service live load showed that after the installation of FRP plates stresses in the main reinforcing steel were moderately reduced, concrete

stresses were moderately increased and transverse live load distribution to the beams was slightly increased. It was also noted that the neutral axis shifted slightly towards the bottom of the beam.

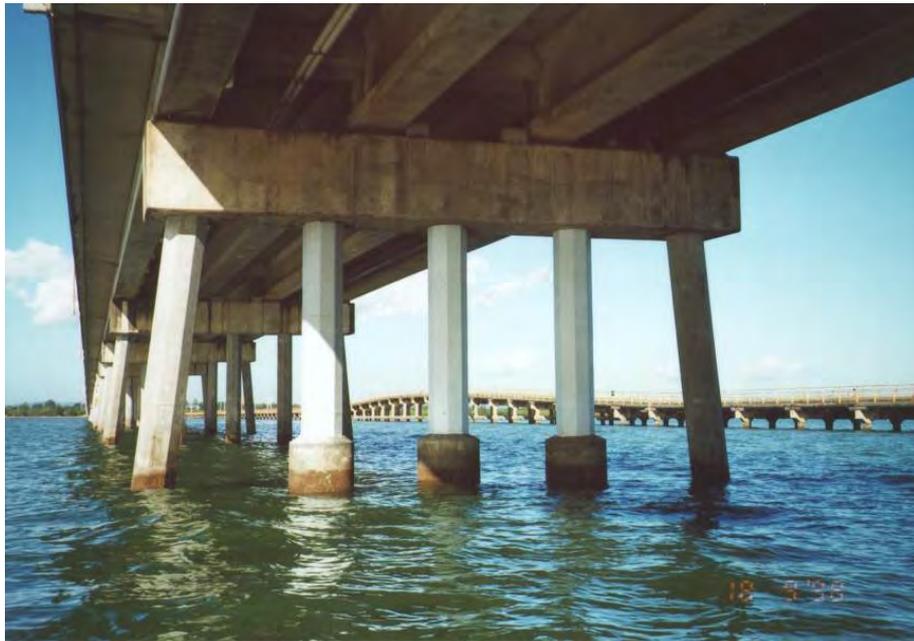
**Figure 8 – Houghton Highway substructure
Source [23])**

The Houghton Highway is a dual carriageway bridge in Australia linking Queensland's capital Brisbane with the northern shire of Redcliffe. The bridge crosses open water at close to sea level and consists of a number of short spans. The structure consists of an integral concrete overlay tied to prestressed concrete T-beams. The beams are used in simple spans between concrete headstocks connecting five prestressed concrete piles at each support (refer Figure 8).

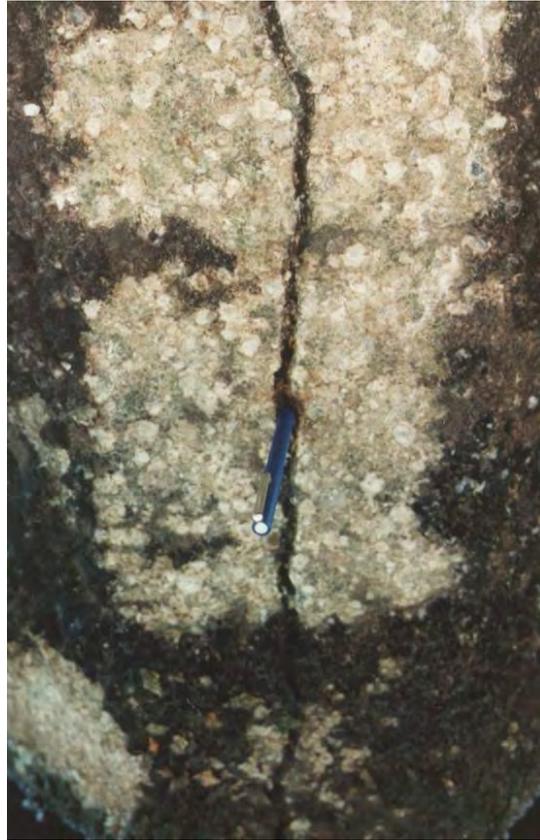
**Figure 9 – Typical longitudinal crack in concrete due to alkali / silica reaction
(Source [23])**

In 1991 routine inspection identified deterioration of the prestressed concrete piles caused by alkali-silica reaction. The result of this reaction was internal cracking of the concrete with crumbling and spalling of the concrete leaving the reinforcing steel exposed to the marine environment. Figure 9 shows a typical longitudinal crack.

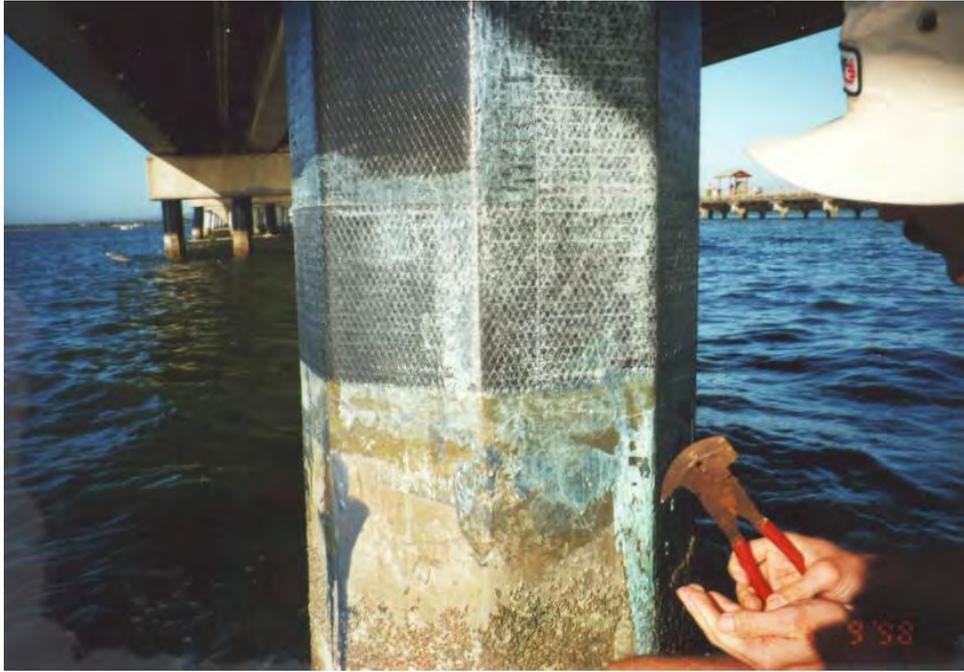
**Figure 10 – Externally bonded CFRP
(Source [23])**

The concrete and steel degradation was too advanced for concrete repair alone and a strengthening system was required to reinstate the columns original capacity and to cover the existing cracks. Due to the octagonal shape of the prestressed columns and proximity of the columns to seawater, the traditional method using steel jackets was eliminated. The upper section of the piles suffering longitudinal cracking is able to be seen by the public and a repair system was required which could cover the damage and contain the existing cracks. Concrete was considered but avoided due to the tendency for cracks to migrate through the concrete encasement. Externally bonded fibre composite materials were identified as potential candidates as they can be applied on site in a pliable form which can easily follow the shape of the column. Fibre composites had also been demonstrated to conceal repaired areas without reflecting previous cracks. Externally bonded fibre composites were also believed to offer adequate re-strengthening as well providing protection of the concrete piles from the environment through resin encapsulation during laminating (refer Figure 10).

In total 500 piles were repaired and the rehabilitation project was completed in the year 2000. Fibre composites were not used below the water surface due to concerns relating to installation and replacement should long-term durability become an issue. The repairs are continuously monitored for in-service performance.
